**YAMPA RIVER  
SCORECARD  
PROJECT**

The YRSP is a long-term river health monitoring and evaluation program for the Yampa Basin that will rate the overall condition of different segments of the Yampa River and articulate results through a “scorecard”. A comprehensive long-term monitoring program has yet to exist in the Yampa Basin.

Friends of the Yampa is leading a community-based process to implement a long-term river health monitoring and evaluation program for the Yampa Basin that rates the overall condition of different segments of the Yampa River and articulates results through a *Yampa River Scorecard*. The first iteration of the Yampa River Scorecard Project (YRSP) is focused on the Middle Yampa River segment of the Yampa main stem, a 39-mile segment from the Hayden pump station to South Beach. Figure 1-1 shows public access points along the Yampa River. The Scorecard focal segment corresponds to points #1 through #6 on this map. The Xcel Pump Station (sometimes referred to as Pumphouse) is a Colorado Parks and Wildlife (CPW) public river access site approximately 5 miles east of Hayden, just upstream of The Nature Conservancy’s Carpenter Ranch in Routt County. The segmen

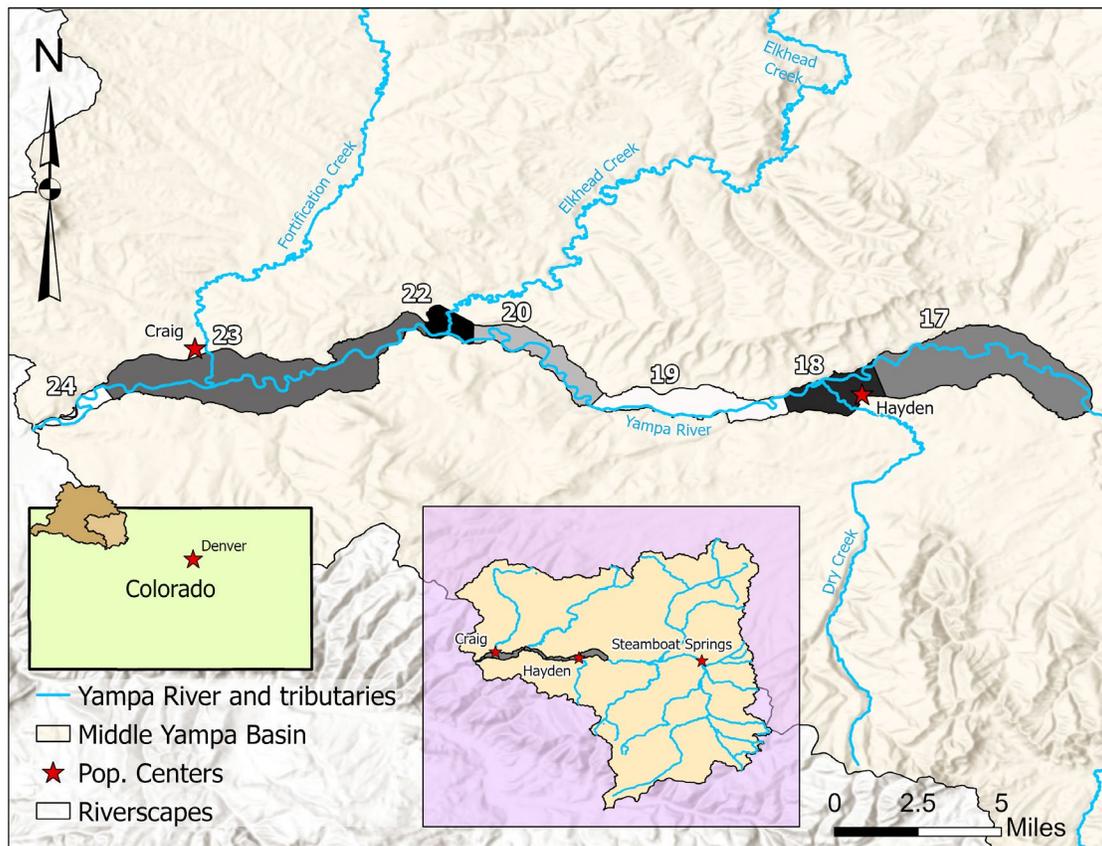
**Figure 1-2. Middle Yampa River Segment Riverscapes**

Seven riverscapes identified in the Yampa Integrated Water Management Plan (IWMP) remote assessment are contained within this segment (Figure 1-2). A score for each indicator will be developed for each riverscape, and then averaged for an overall riverscape score (refer to Section 11 for more information). A weighted average across the seven riverscapes will then be calculated to generate an overall ecological health and function score for the Middle Yampa River Segment.

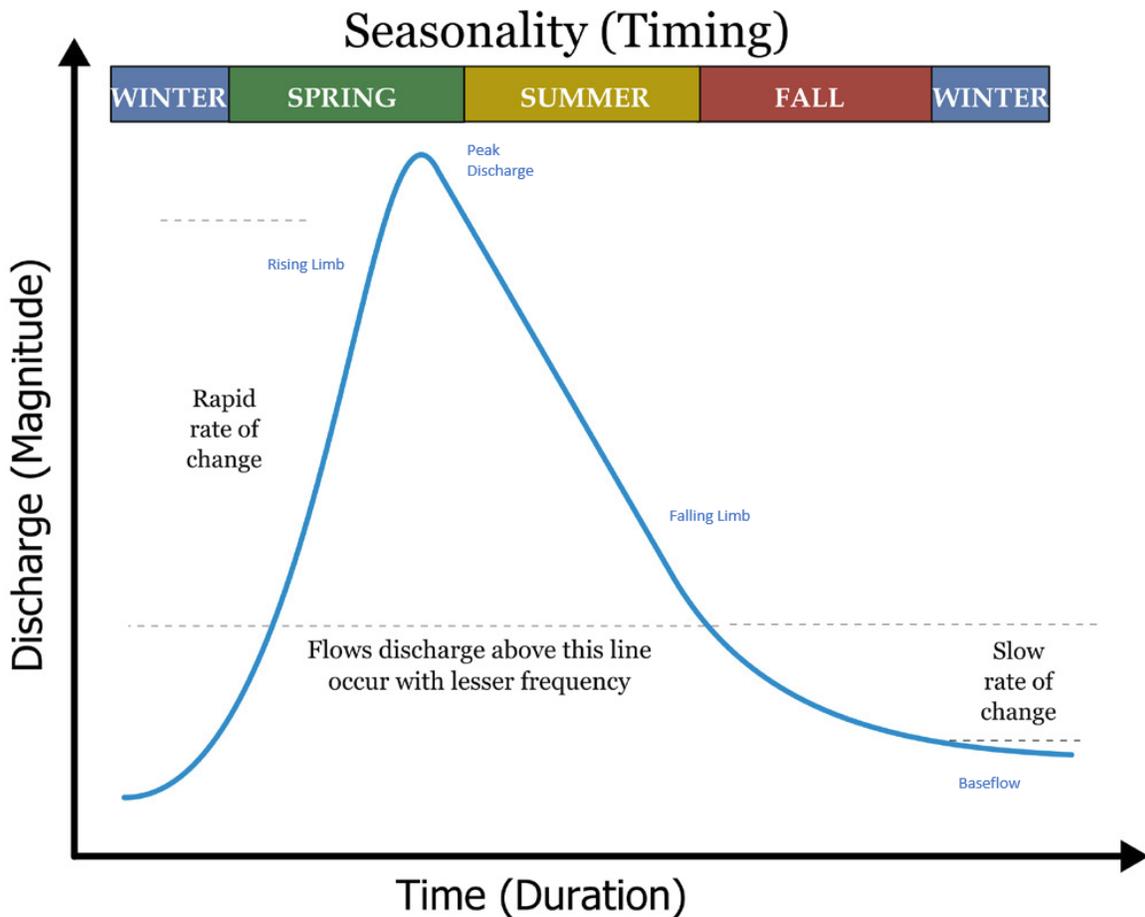
Figure 2-1. Hydrograph Schematic Diagram

The hydrograph indicator considers the following components of the Yampa River's flow regime:

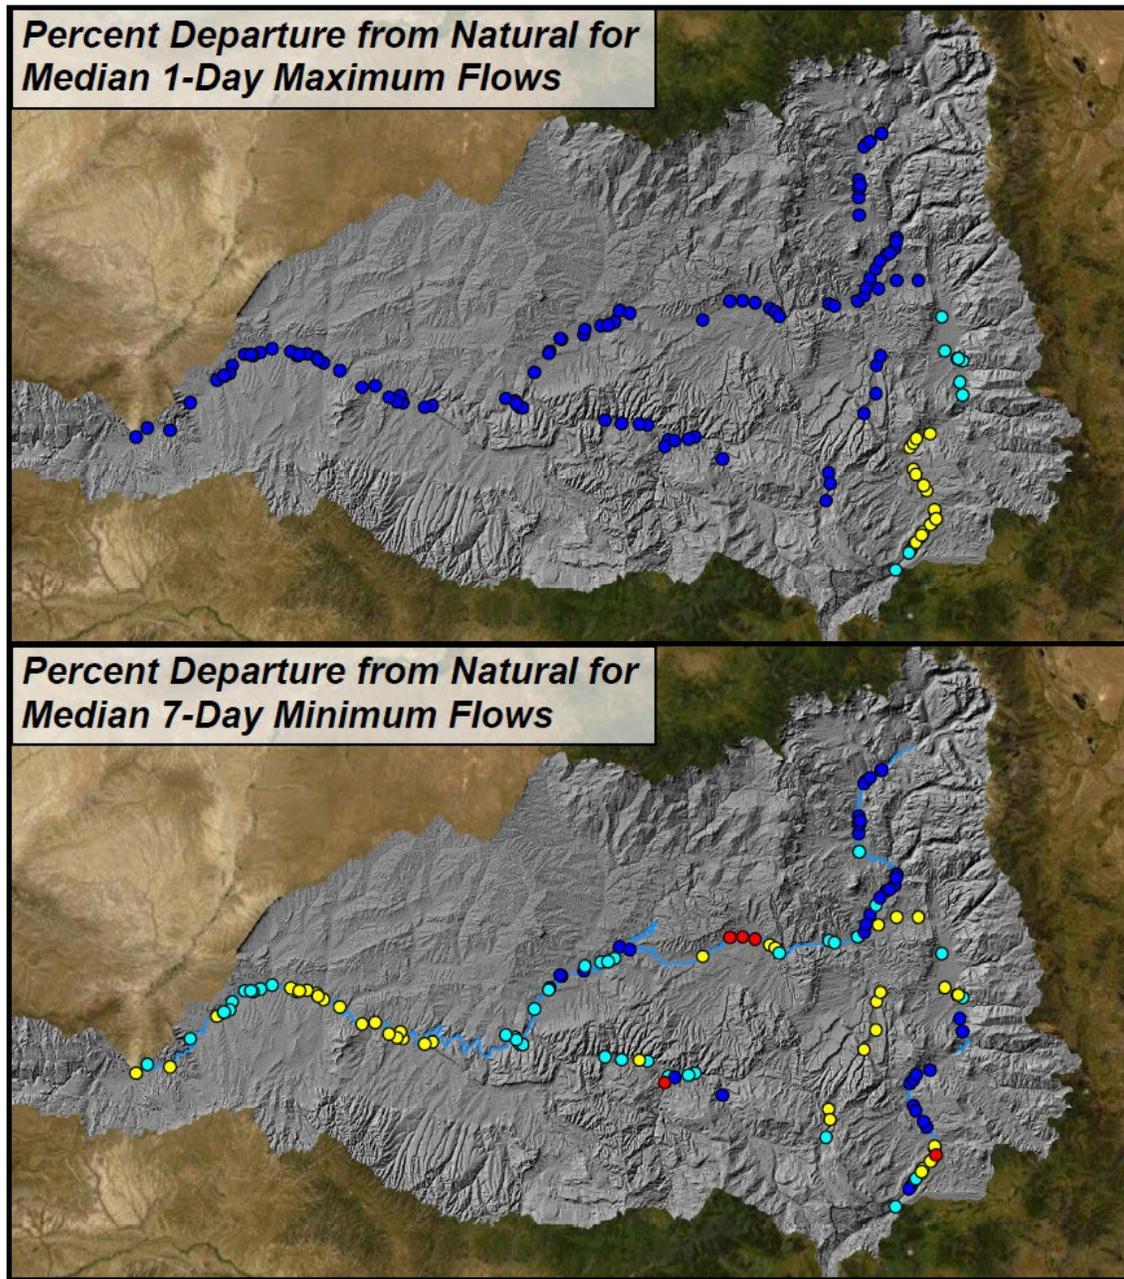
Figure 2-2. Yampa IWMP Remote Assessment Flow Regime Percent Departure Plots

The Yampa IWMP remote assessment’s Data Synthesis Report (Yampa IWMP 2021) applied these data to percent departure of baseline conditions from natural conditions for two metrics: (1) percent departure of high flows and (2) percent departure of low flows. The two metrics were used in the remote assessment to provide a high-level, holistic indication of flow regime alteration within the Yampa basin (Figure 2-2). A more detailed hydrologic analysis of more than 107 metrics is presented in the Yampa River Hydrologic Review and Needs Assessment Report (Lotic 2021). This report and its associated data are used to rate this indicator.

Percent departure in median annual 7-day minimum flow is a metric that reflects the degree to which low flows have been altered from natural conditions. Modeled departures of 7-day minimum flows from natural conditions are substantial for riverscapes in the vicinity of Hayden – differences are 68% and 57% in riverscapes 17 and 19, respectively. Below Hayden, alteration is notably more minimal; riverscapes 22, 23, and 24 have departures of 14%, 18%, and 14%, respectively (Yampa IWMP 2021, Lotic 2021). Though these differences between baseline (current) flow and natural flow are significant, they are of relatively low magnitude (Lotic 2021). As above, modeling results were not reported for riverscapes 18 and 20 due to the lack of modeling nodes located in these reaches.

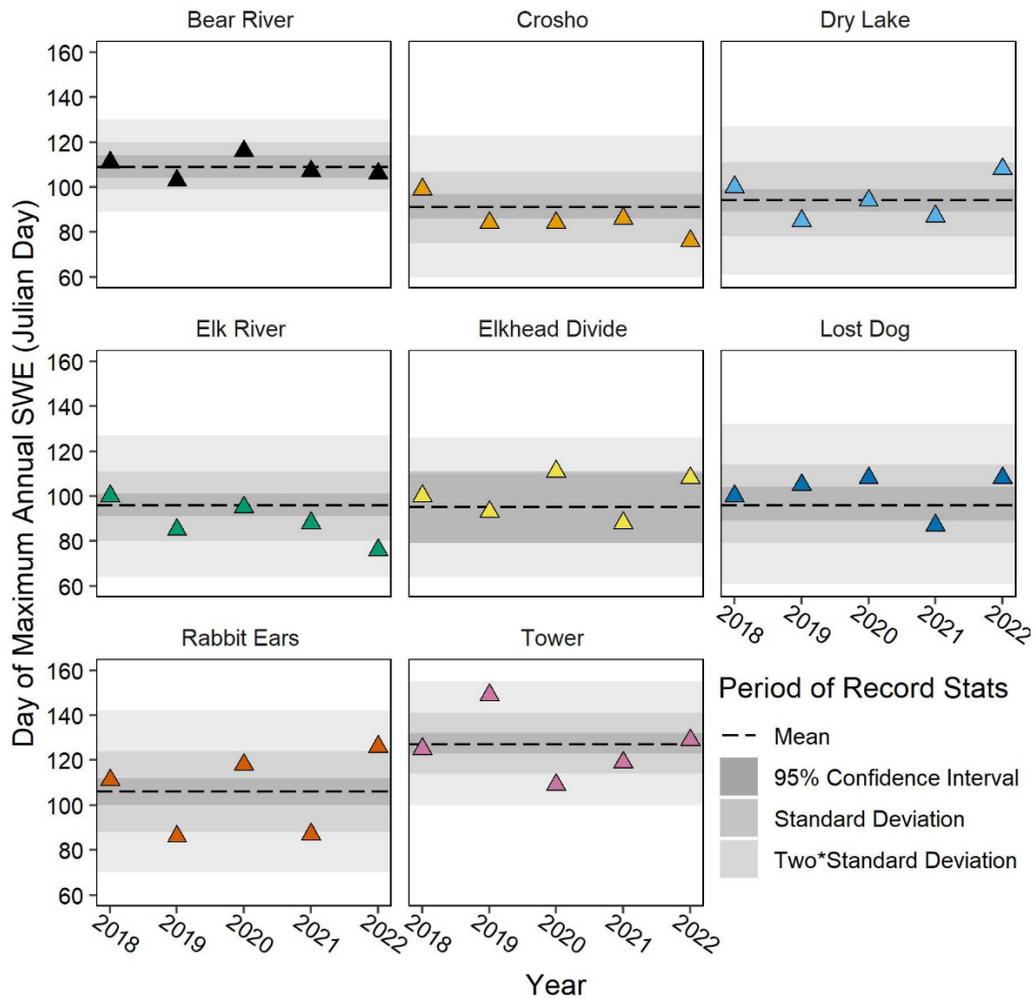
**Figure 2-6. Timing of Maximum Annual SWE Volume (2018-2022) Compared to Long-Term Data**

Figure 2-6 shows the timing of maximum annual SWE volume (day of year) for the past five years of data compared to the long-term mean (dashed line), 95% confidence interval (dark gray), and standard deviation (medium gray) generated from the period of record data. Timing of maximum SWE displays few observable patterns outside of 2018, when the day of maximum SWE was not significantly different than the overall mean at all stations (Figure 2-6). Overall, timing of maximum SWE is within a single standard deviation of the mean for all years at 5 of the 8 SNOTEL stations. The exceptions are Tower, Rabbit, and Elk River, which have one (Tower and Elk River) and two (Rabbit) years that fall below a single standard deviation (though within two standard deviations) of the mean. These stations thus earn the lowest grades (Table 2-5).

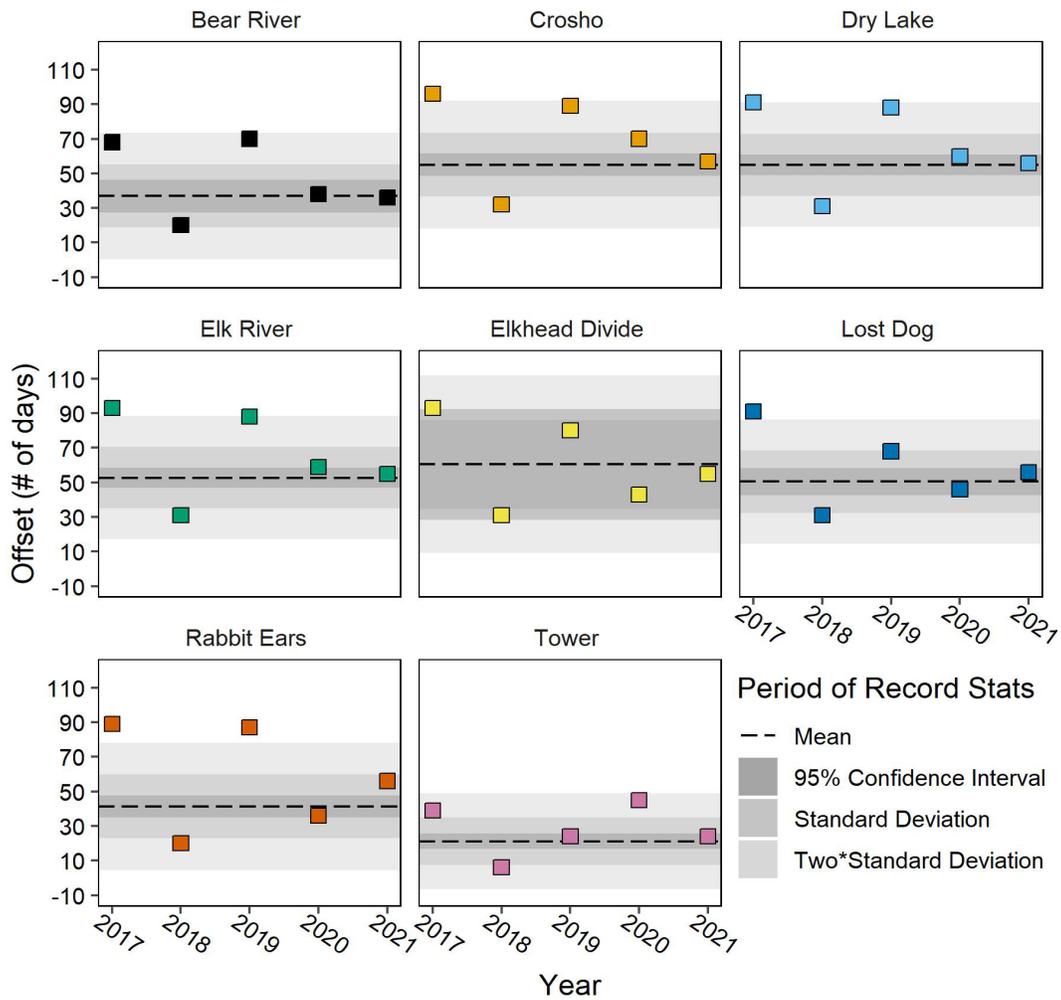
**Figure 2-7. Offset of Maximum Annual SWE Volume and Peak River Discharge (2018-2022) Compared to Long-Term Data**

Finally, the length of time (i.e., offset) between the timing of peak SWE and the timing of peak streamflow is noticeably different over the most recent five years than the mean for the period of record at each site (Figure 2-7). In general, the offset in 2017, 2018, and 2019 was significantly different than the period of record at all stations; 2020 and 2021 were more similar. Scores for this indicator range between B+ and D. (Table 2-5).

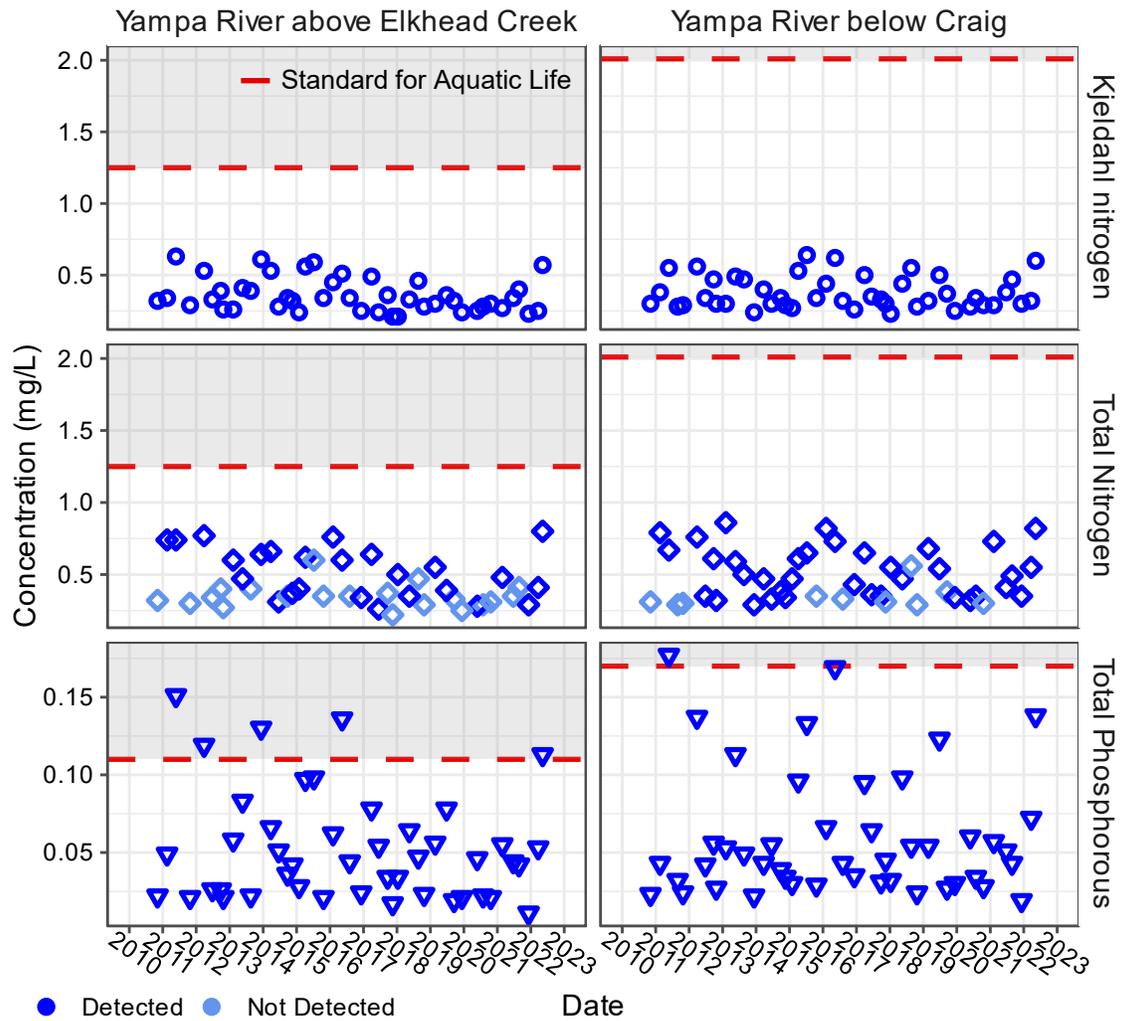
**Figure 4-7. Measured (Discrete) Kjeldahl Nitrogen, Total Nitrogen, and Total Phosphorus Values for the Yampa River above Elkhead and Yampa River below Craig Gaging Stations**

Like nitrogen, total phosphorous (TP) is measured quarterly at both stations in the study area, and these quarterly samples were used to estimate daily TP concentrations. Estimated median annual total phosphorous (TP) was below the interim regulatory standard of 0.11 mg/L for cold water rivers and 0.17 mg/L warm water rivers for all water years over the analyzed period for both sites (Table 4-11, Figure 4-6). However, summarizing the data at the annual scale obfuscates some trends; at closer examination, estimated daily concentrations exceeded the standard fairly frequently during the spring months. Median monthly values of TP for the period analyzed exceed the cold-water regulatory standard in both April and May at the above Elkhead station (Figure 4-6). Additional information is provided by examining the modeled data at the daily scale; exceedance occurs for a number of days in March-June. For the above Elkhead station, median number of days over the period of record in which the water quality standard is exceeded are 3, 21, 29, and 10.5 days for March, April, May, and June, respectively; however, at the below Craig site, the median number of days in exceedance are 0.

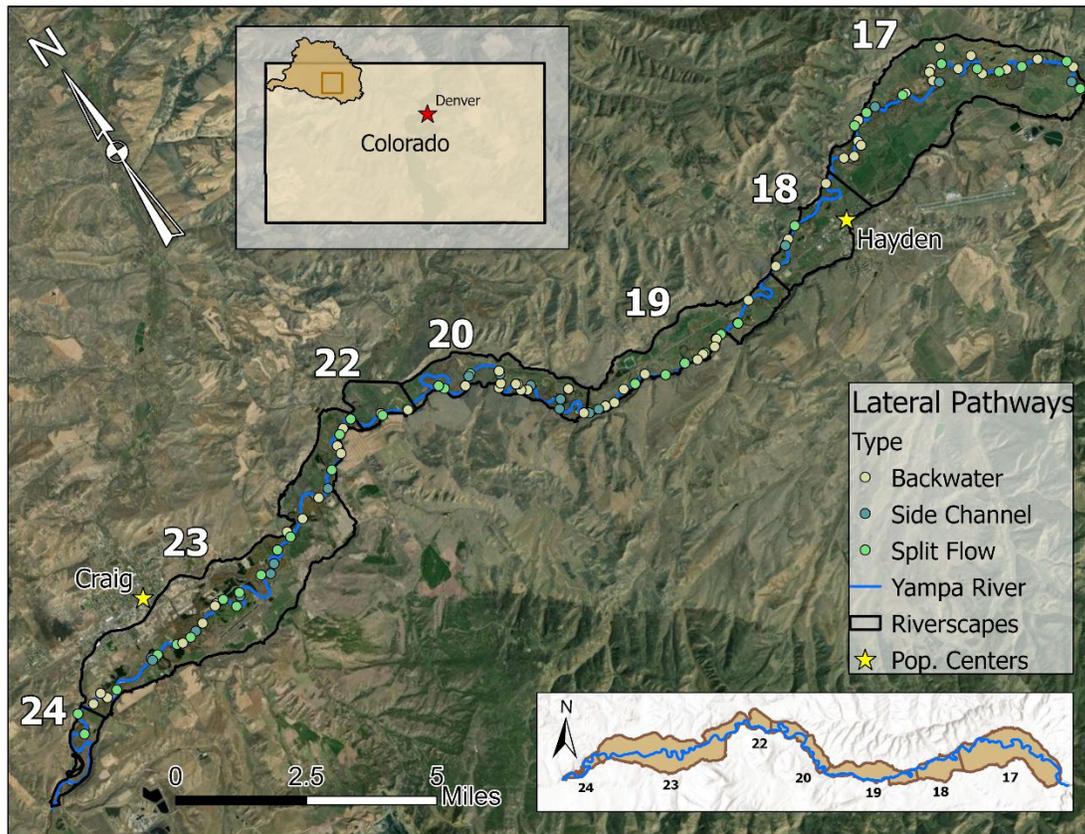
**Figure 5-2. Locations of Pathways for Lateral Movement as Observed in the Field**

Pathways for lateral movement (e.g., side channels) are commonly found along the Yampa throughout the study area. The presence of such features enables aquatic organisms to extricate themselves from the higher energy of the main channel into relatively sheltered and quiescent waters. Lateral connectivity pathways are thus important for spawning and rearing of several species of fish, as well as for other organisms that may move frequently between the main river channel and the neighboring floodplain (e.g., beaver). Lateral pathways scores were determined by (1) calculating the number of such features observed in the field and on imagery per river mile, and then (2) evaluating that number relative to what may be expected of a natural river in its process domain using the following rubric, which dovetails with the scoring criteria laid out in Section 5.1.2: No loss of side channel access (>4/mile); mild loss of side channel access (<4/mile); moderate loss of side channel access (<3/mile); substantial loss of side channel access (<2/mile); and full loss of side channel access (<1/mile). Lateral pathways were most frequent and widespread in riverscapes 17, 19, 20, and 23 (Figure 5-2); these riverscapes therefore earned the highest scores (Table 5-2). Inspection of aerial imagery suggests that high scores may be a function of the presence of substantial portions of intact riparian forest along these riverscapes, emphasizing the benefits of preserving such floodplain ecosystems for the river. A notably low score for the presence of lateral pathways occurred in riverscape 24, likely due to the fact that the river here is bounded by a large interstate highway and a railroad.

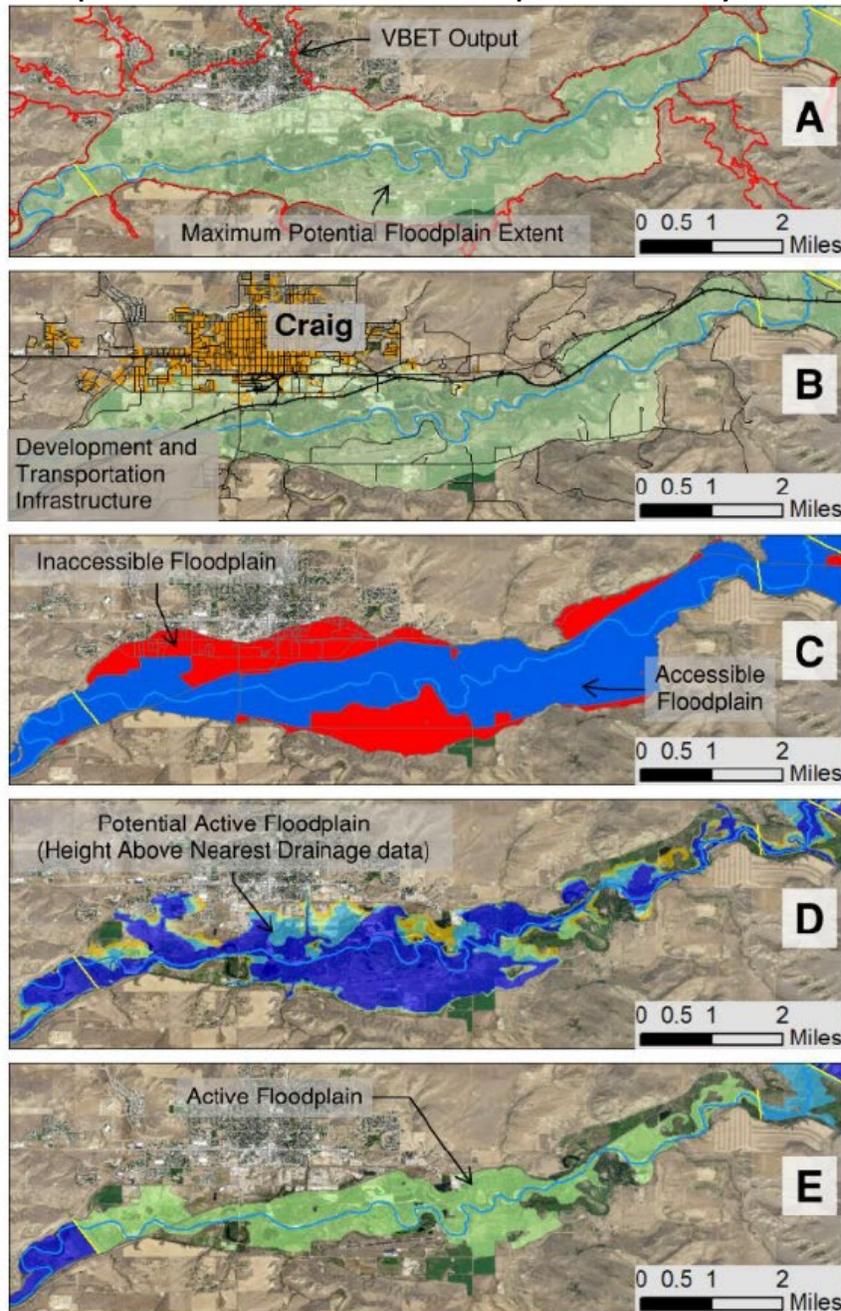
**Figure 6-1. Yampa IWMP Remote Assessment Floodplain Connectivity Metrics Example**

Figure 6-1. Example floodplain connectivity metrics for Riverscape 23 (see Figure 2-4 for context). A) VBET outputs and manually modified valley bottom representing the maximum potential floodplain extent. B) Development and transportation infrastructure overlain on valley bottom polygon. C) Floodplain fragmentation by development and transportation network. D) Potential active floodplain based on Height Above Nearest Drainage. E) Active floodplain.

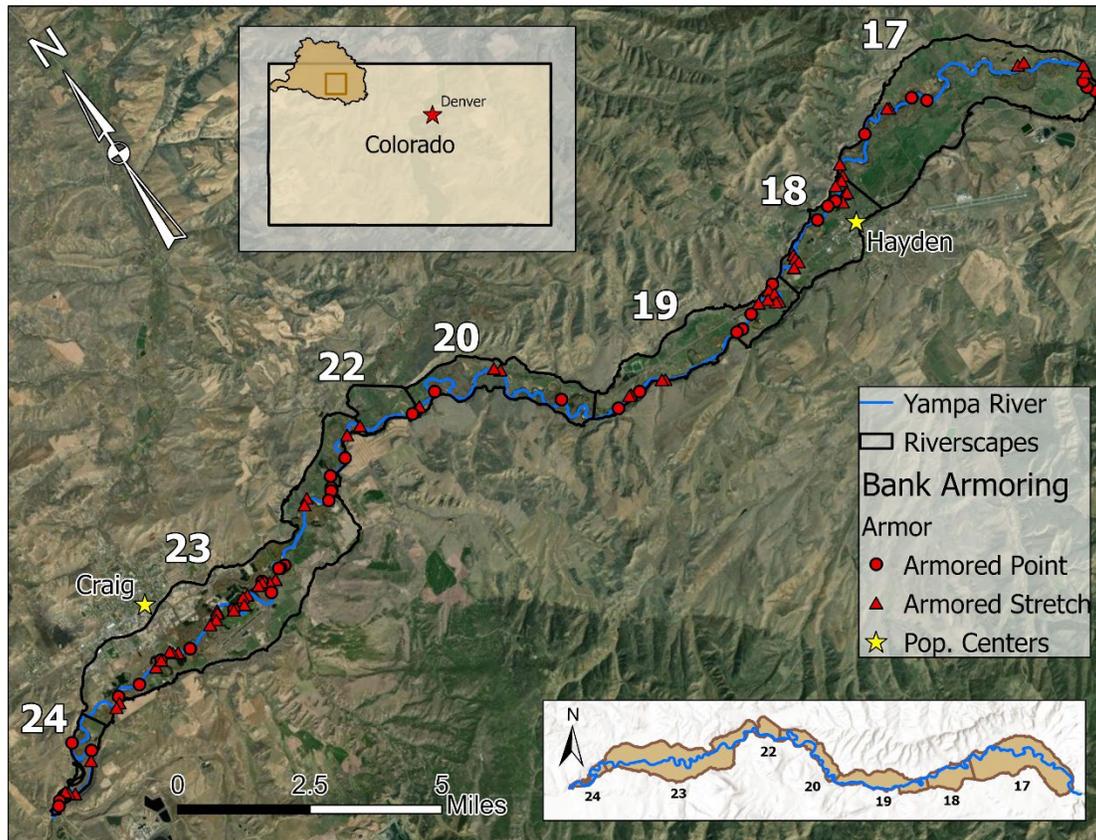
**Figure 9-1. Bank Armoring Across the Middle Yampa Segment by Riverscape**

Likely as a function of this relatively light armoring, riverscapes 17 and 20 also have extensive occurrences of features indicative of complexity such as backwaters and side channels/split flows (Figure 5-2). As mentioned above, this may result from the additional “freedom” of the river to migrate across the floodplain in these sparsely armored reaches. Interestingly, despite the fairly frequent occurrence of armoring in reach 23, complexity features are somewhat abundant; this is perhaps due to the preservation of the natural floodplain ecosystem in many areas. Relatedly, there is relatively extensive occurrence of large wood and bar surfaces in reach 23 (Figure 9-2), both indicators of comparatively natural riverine complexity.

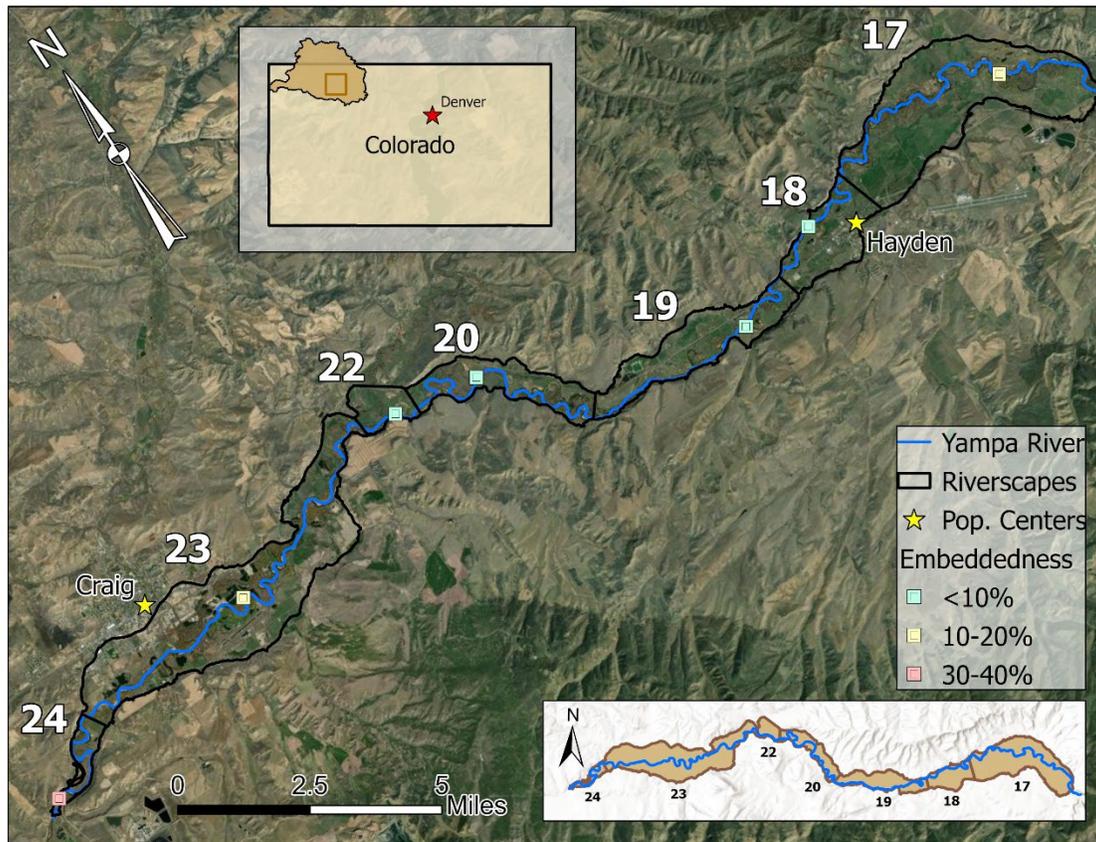
Figure 9-4. Embeddedness Locations and Ranges by Riverscape

The highest embeddedness scores were recorded in riverscape 24 and were 30-40%. This is in line with the similarly low scores in other indicators for this riverscape. Interestingly, embeddedness values are consistently low from riverscapes 18-22, then increase relatively in 23 and 24, a spatial trend that is perhaps reflective of the role of Elkhead Creek (which flows into the Yampa in riverscape 22) in supplying the excess fine sediment that results in higher embeddedness values.

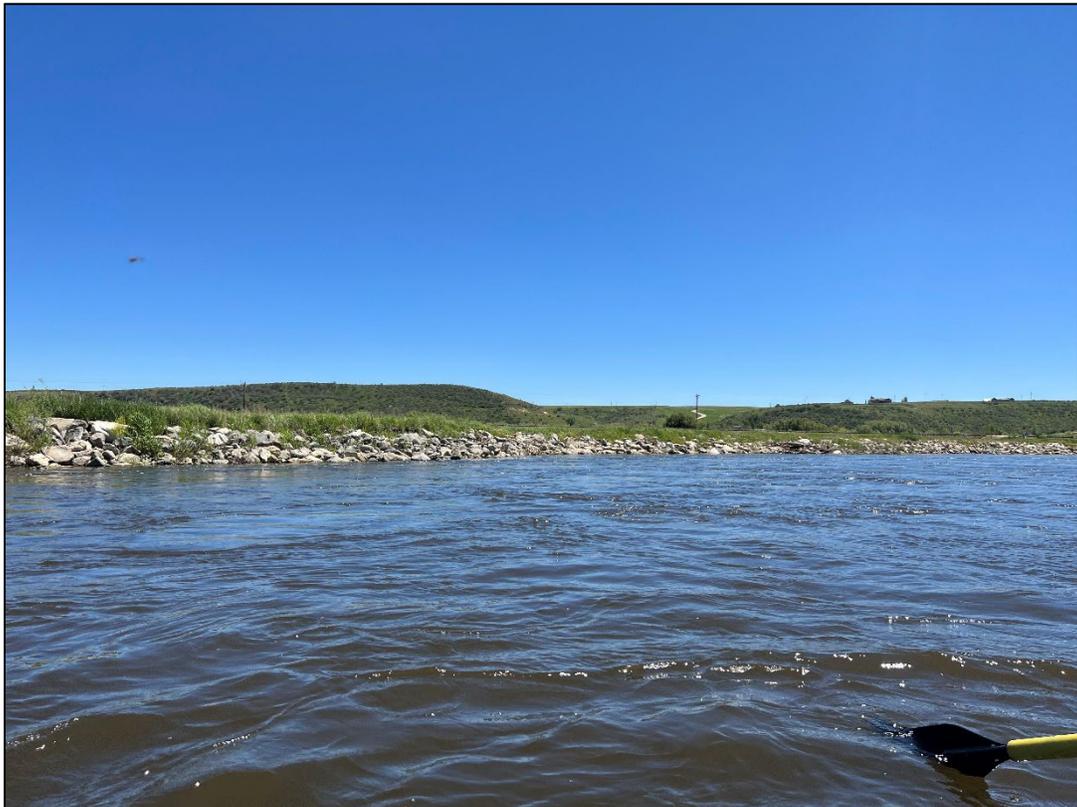
**Figure A-4. Bank armoring with large boulders.**

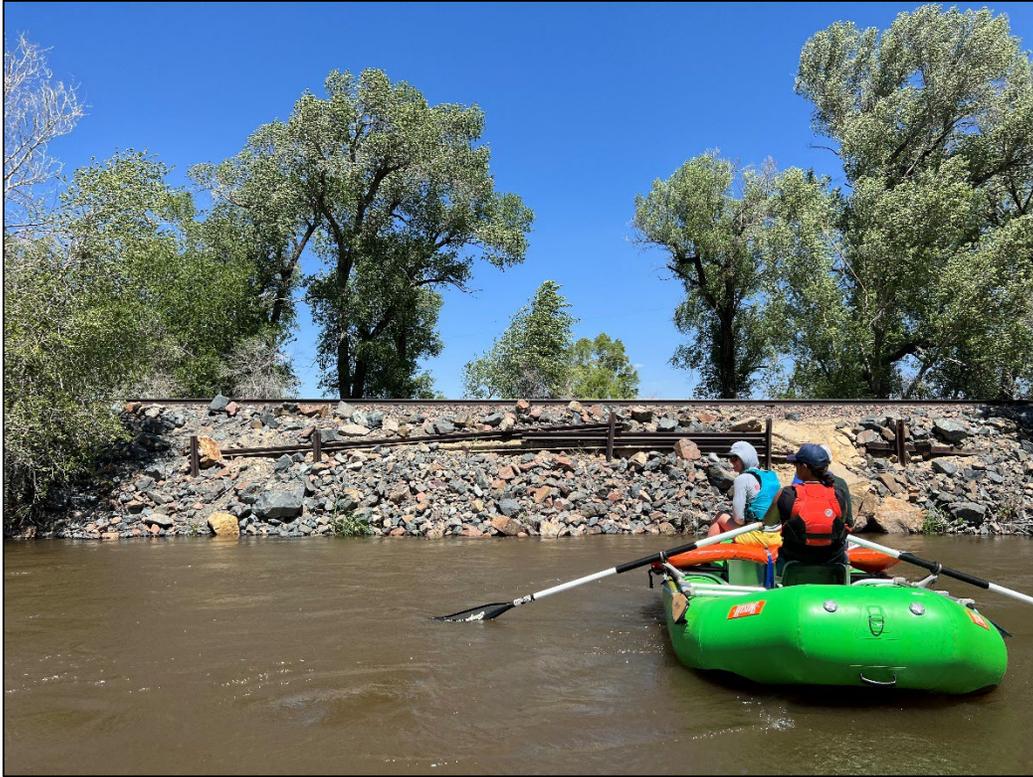
**Figure A-5. Bank armoring to protect railroad infrastructure.**

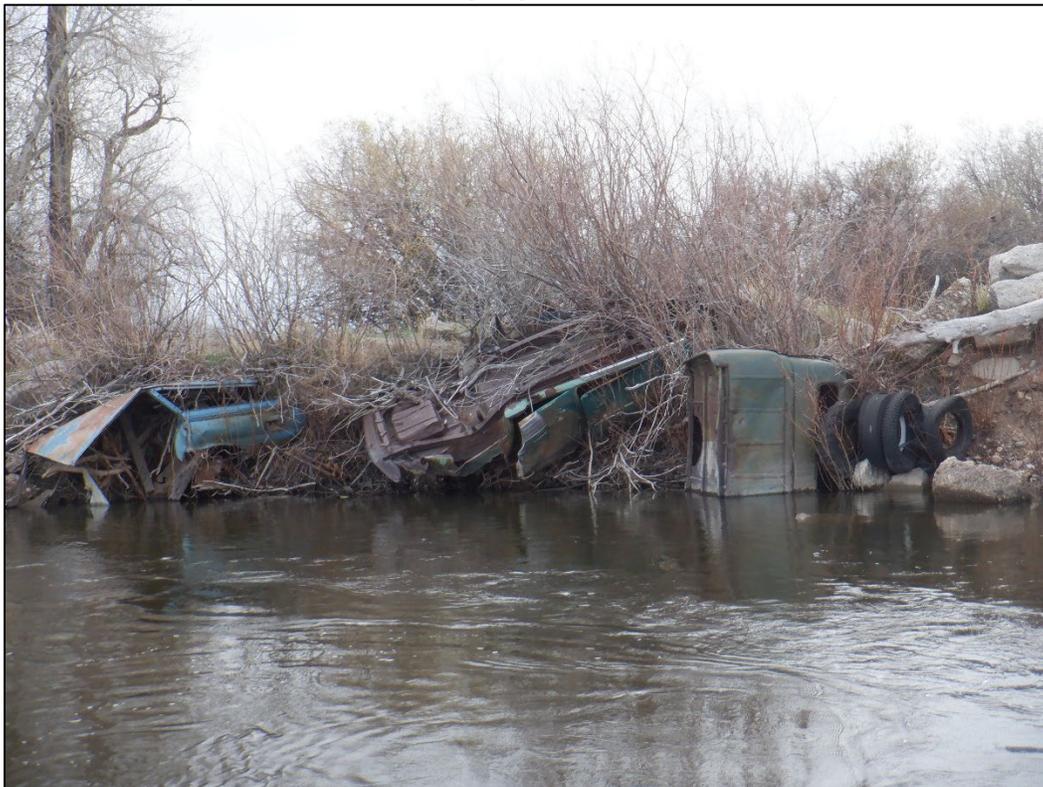
**Figure A-6. Bank armoring with old automobiles and other trash.**

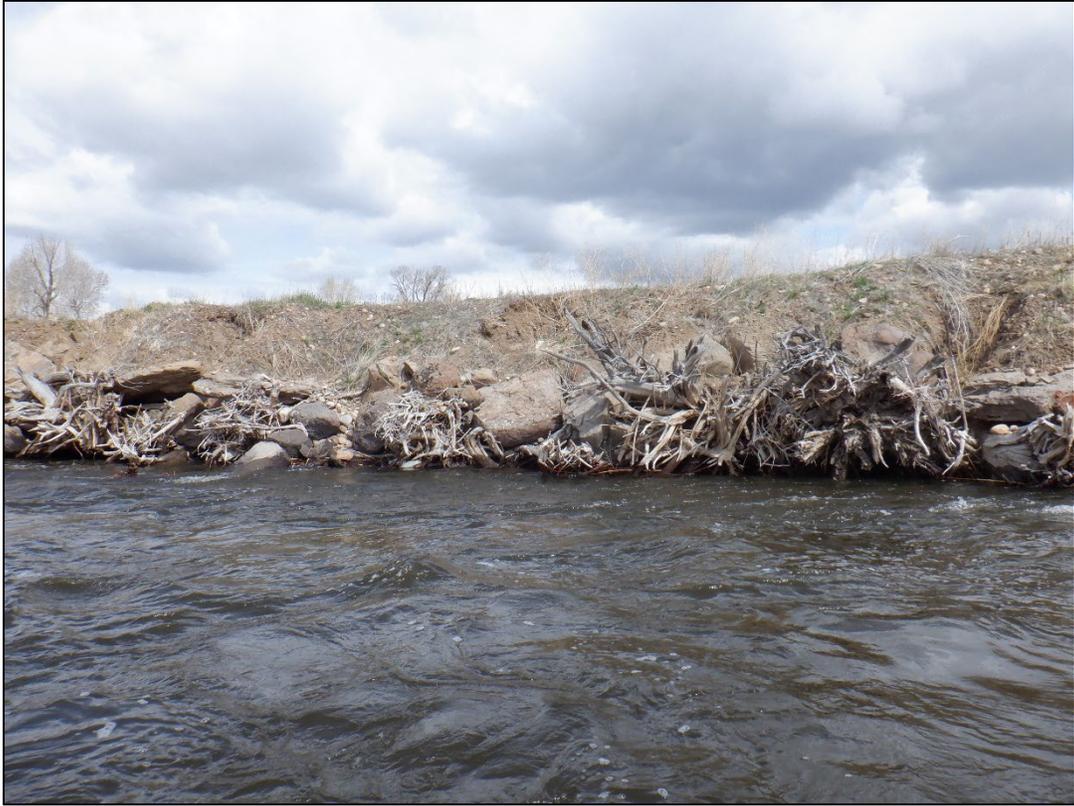
**Figure A-7. Bank armoring with rootwads and large boulders.**

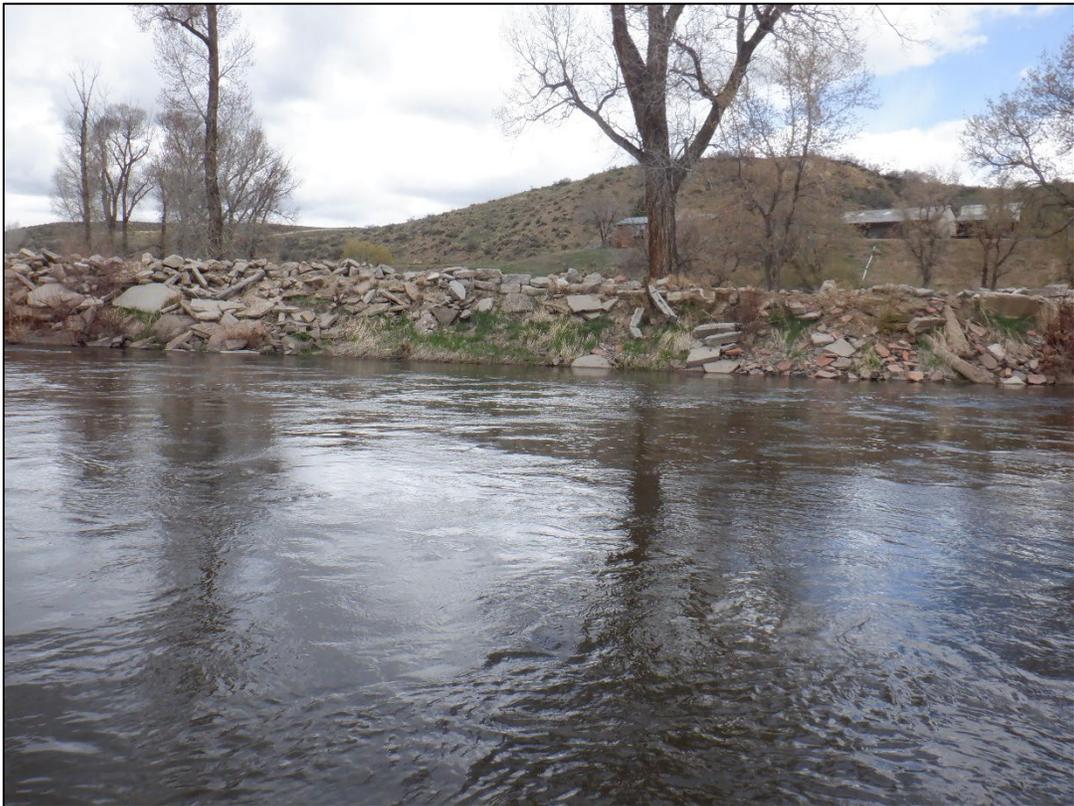
**Figure A-8. Bank armoring with concrete.**

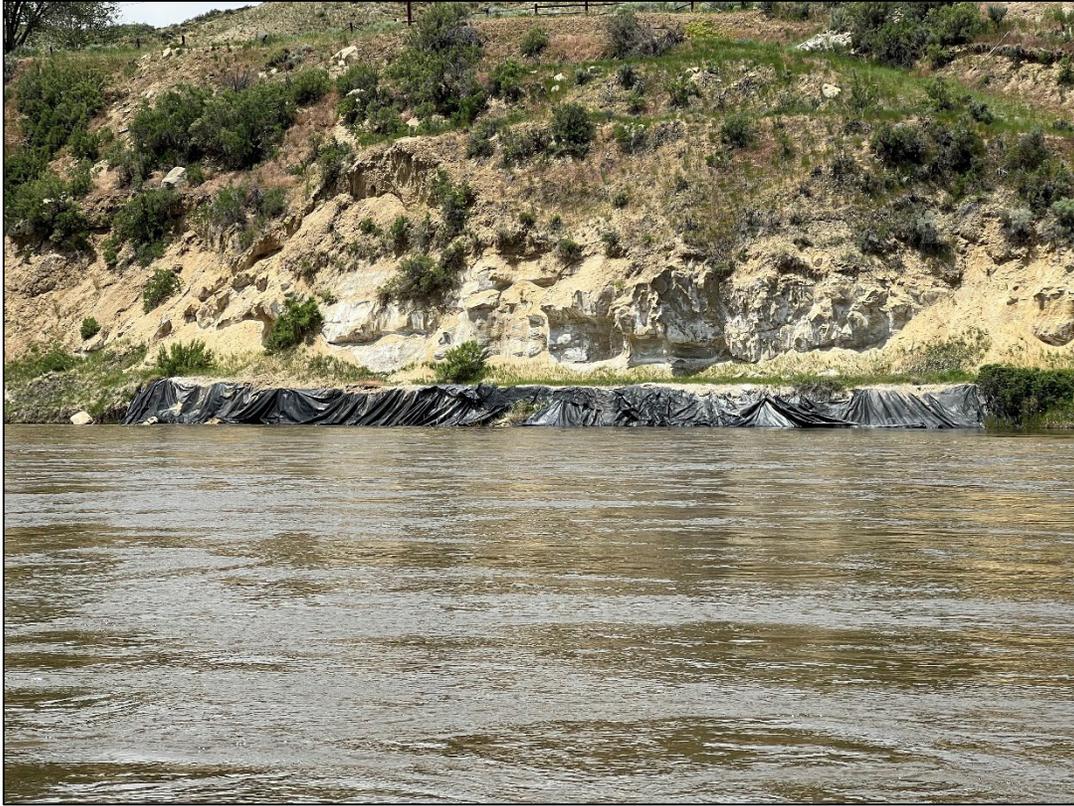
**Figure A-9. Bank armoring with heavy plastic.**

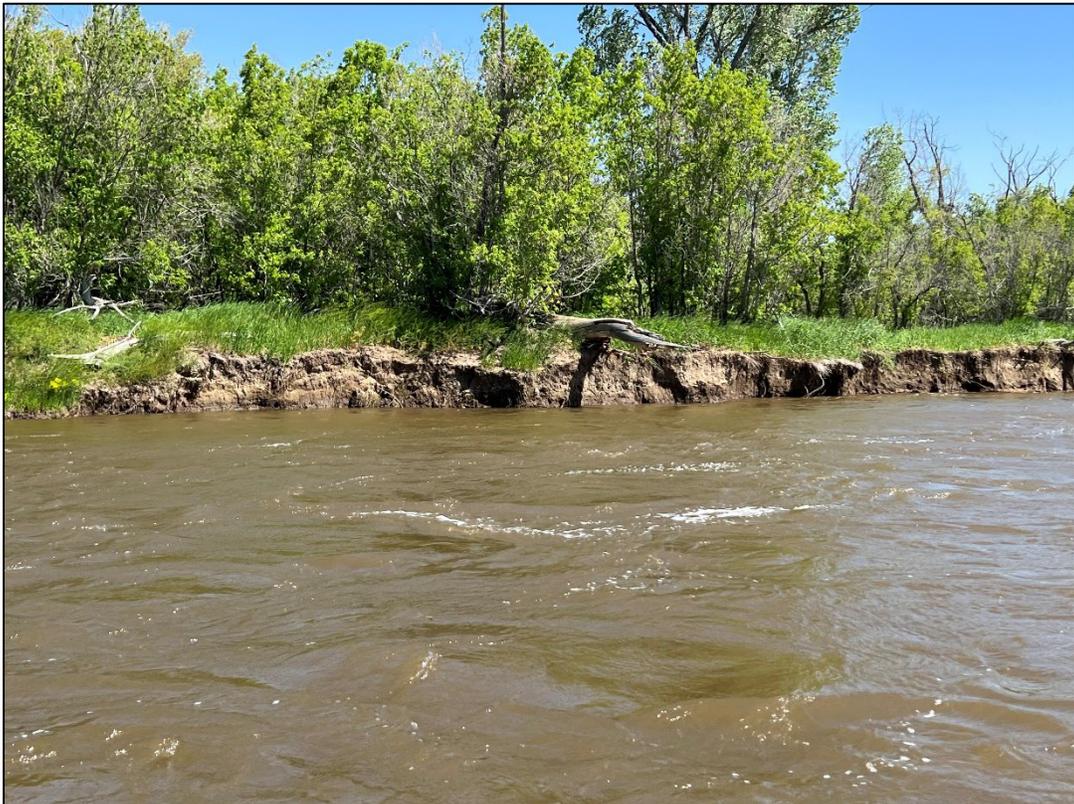
**Figure A-10. Bank erosion on the outer bend characteristic of a health meandering river.**

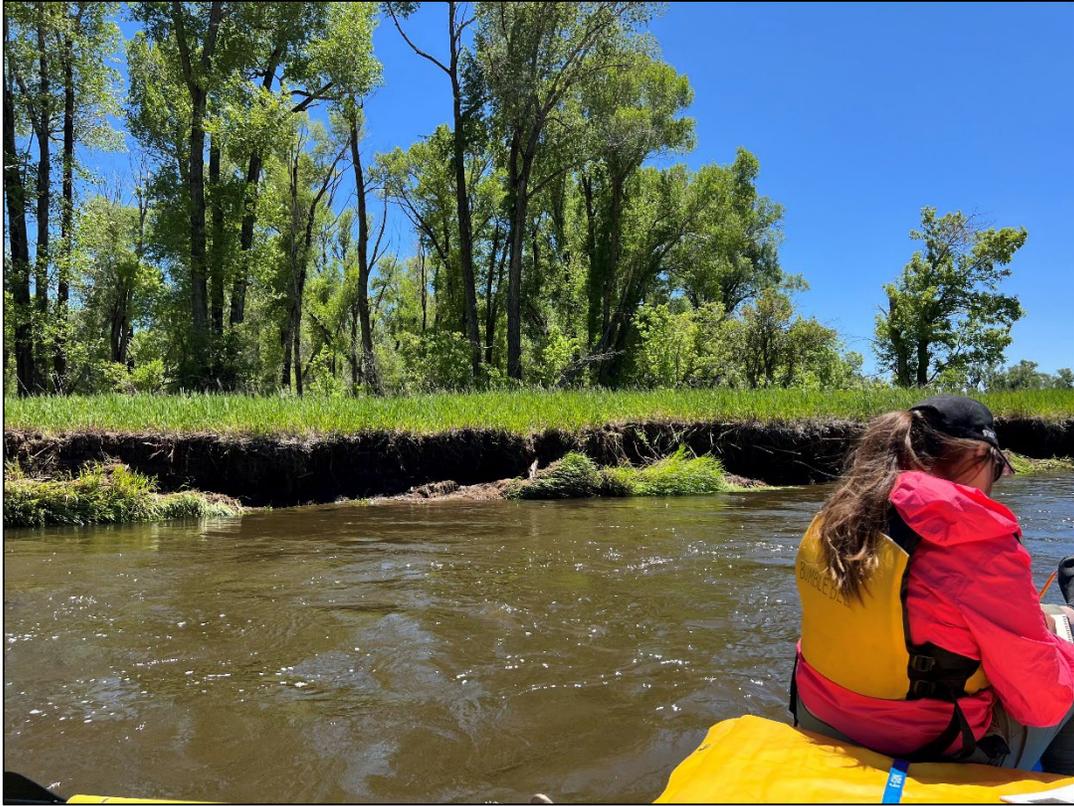
**Figure A-11. More healthy bank erosion.**

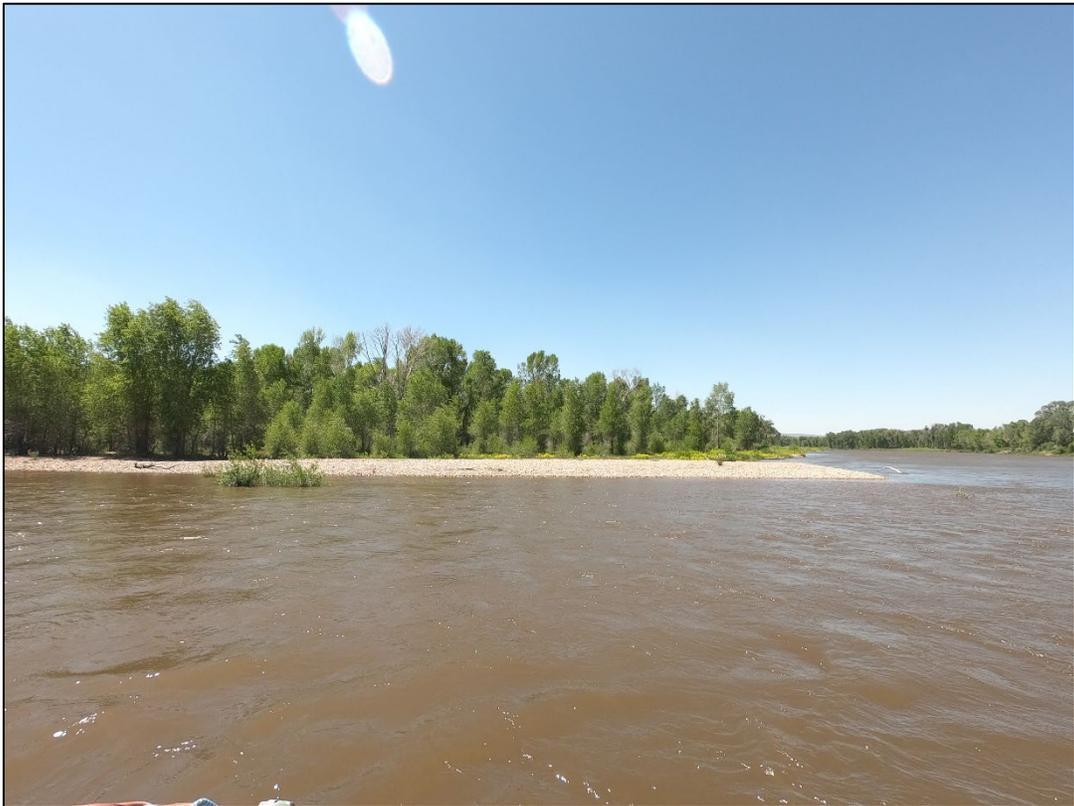
**Figure A-12. Gravel bar indicative of a healthy sediment regime.**

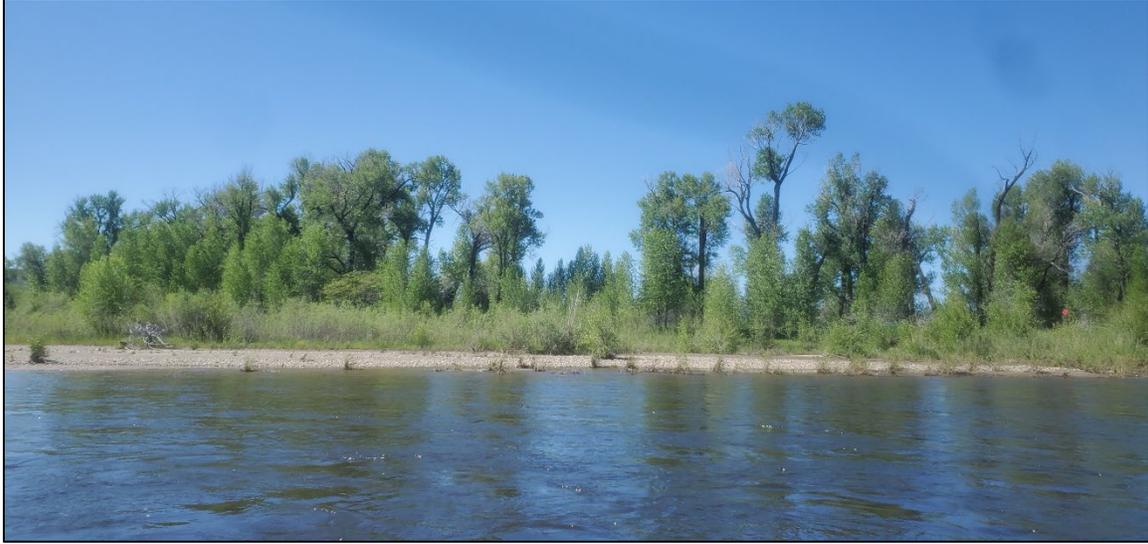
**Figure A-13. Gravel bar (again, suggestive of a healthy sediment regime).**

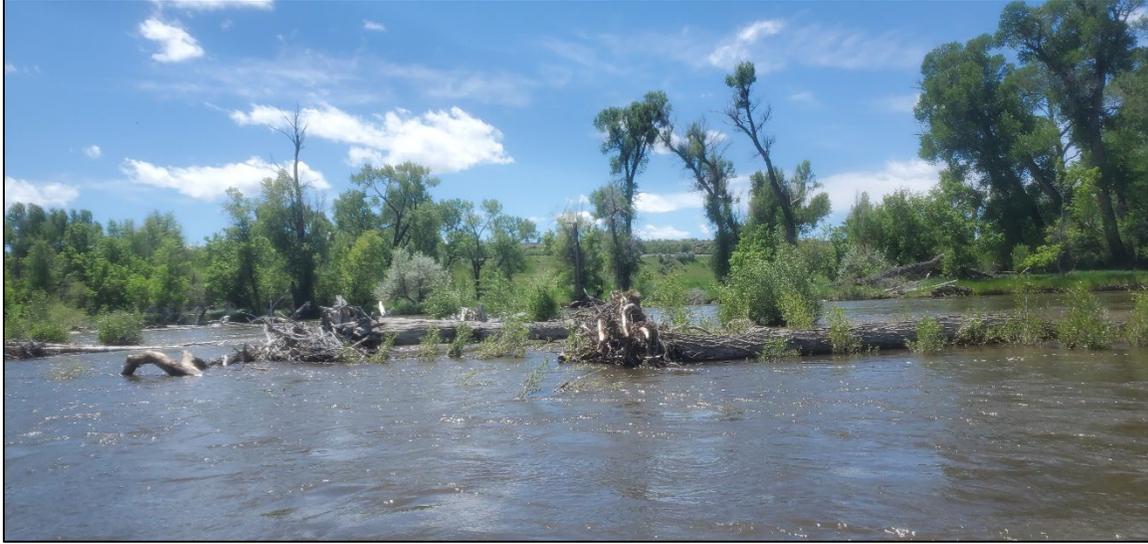
**Figure A-15. Large wood accumulation on a mid-channel bar.**
